# Manhole Inspection Summary

Manhole # S47G\_\_013MH

**Location** Address: **300 Gough St**

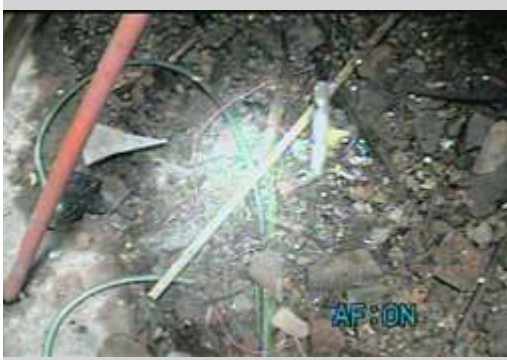
Defect 5

Condition: ☐ Sound ☐ Cracked ☐ Root Intrusion ☐ Deteriorated ☐ Leaks ☒ **Debris**

channel debris

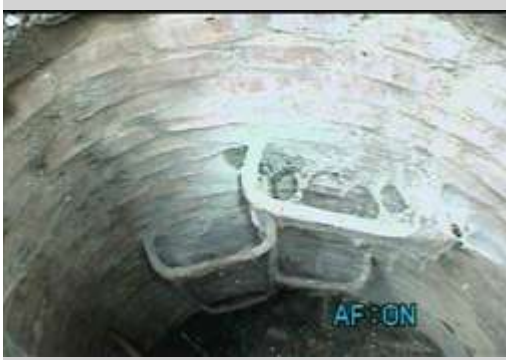
Defect 4

Count: **4** Missing: **0** ☒ **Corroded**

steps

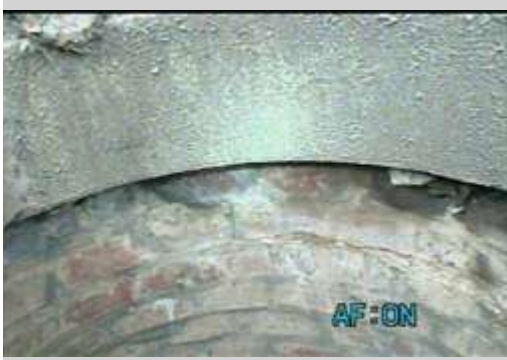
Defect 3

Condition: ☐ Sound ☒ **Cracked** ☐ Root Intrusion ☐ Loose Brick ☐ Deteriorated

cracked corbel

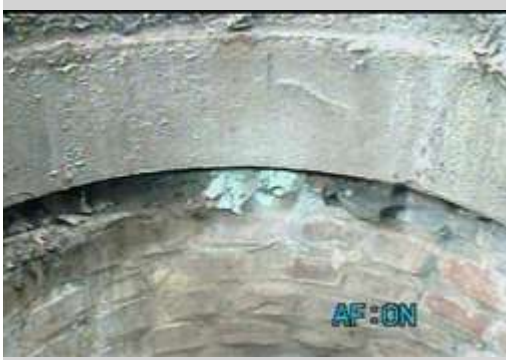
Defect 2

Condition: ☐ Sound ☐ Cracked ☐ Root Intrusion ☐ Loose Brick ☒ **Deteriorated**

deteriorated frame adjustment

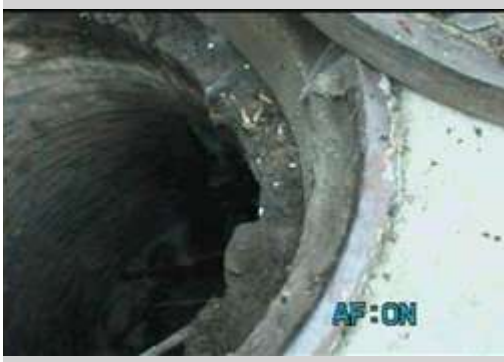
### Defect 1

Offset: **3** (in.)

off set frame

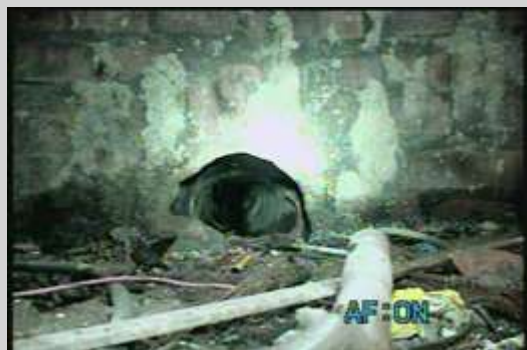
12 O'Clock Outflow

Deposits: ☐ None ☐ Mud ☐ Sludge ☒ **Debris** ☐ Grease

Silt Depth: 1 (in.) Deposits Extent: **Light**
